# Case Study

**Project:** Lancashire Police Constabulary Training Centre  
**Product/System:** Tor Coatings Elastaseal 15 Year System  
**Size/Value:** 1100m<sup>2</sup>

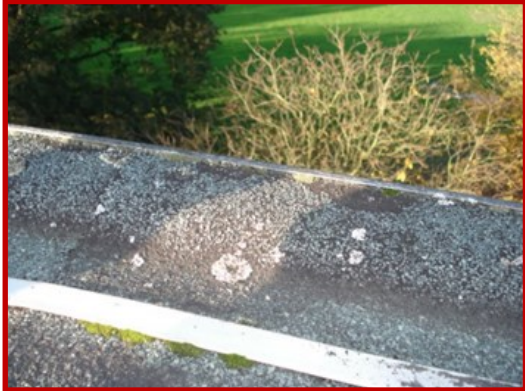
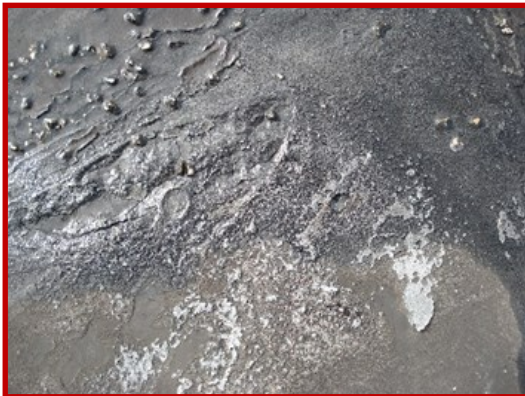
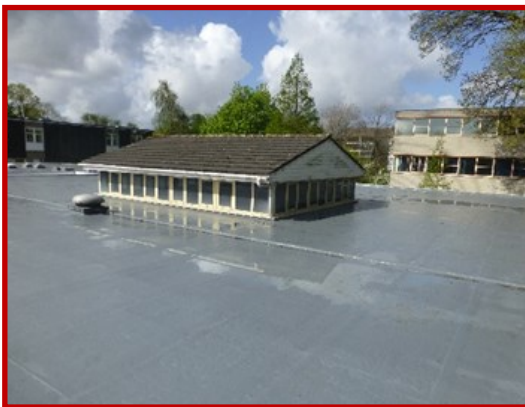
Lancashire Police had severe water ingress from the failure of the old bitumen felt roof covering. The building had to remain in constant use throughout the project, therefore hot works and noise disruption from stripping the old felt system was not acceptable to the client.

In order to maintain full functionality of the training centre during the re-roofing works, Gables offered a cold applied, breathable liquid membrane that was able to be applied directly to the existing felt, eliminating the risks and disruption associated with hot works and stripping coverings.

All moss algae and stone chippings were removed from the deck. Any previous failed repairs were removed and made water tight. The roof was power washed to remove all surface contaminants before applying the Tor Coatings Elastaseal system, consisting of a fully reinforced base coat and a liquid applied top coat giving a 15 year single point guaranteed system.

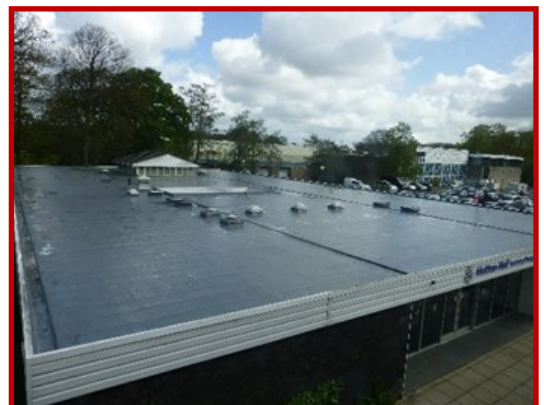
The quality of finish on handover, can clearly be seen on completed application photographs.
