Case Study

Project: St Mark's House, Birkenhead

Product/System: Sika Liquid Plastics Decothane HS & Flexcrete Technologies Ltd Monolevel 844SP

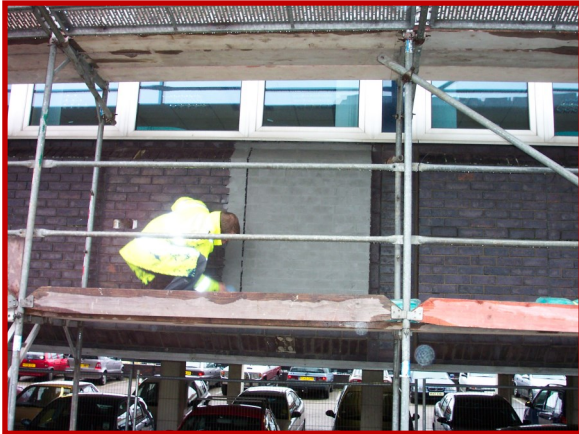
St Mark's House, an office block in Birkenhead, was suffering from water ingress through the walls. The construction below the windows on each floor consisted of brick slips mounted on a prefabricated board. The brick slips were becoming loose and falling off in places, causing the water ingress and presenting a potential danger to the office workers below.

Flexcrete Monolevel 844SP, a cementitious repair mortar, was used to flush point the brick slips and hold them in place. Decothane HS, a seamless waterproofing membrane, was then applied to fully waterproof the building and ensure that no further spalling would occur.
