Case Study

Project: Block D – Walton le Dale Arts College and High School, Lancashire

Product/System: Tor Coatings Elastaseal 20 Year Waterproofing System with Roof Light Replacement x 91

Size/Value: 1,820m²

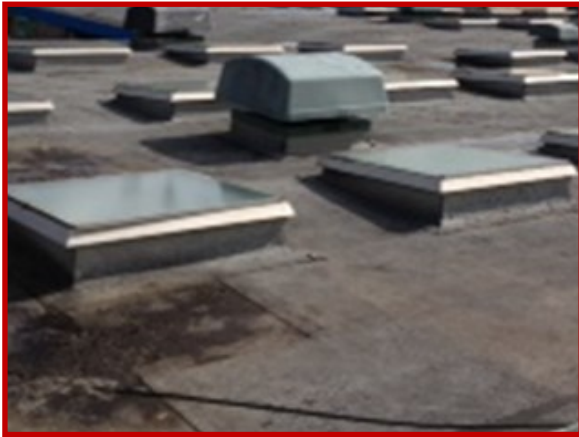
The college roof had a bitumastic, mineralised membrane that had failed and was allowing water into the building. There were numerous areas of failure including open seams and splits around areas of detail. The college had attempted spot repairs but the roof had reached the point where further patch repairs were no longer an option.

Gables offered the solution to overhaul and prepare the main flat roof area and apply a new 20 year waterproofing membrane directly over the prepared existing roof membrane, negating the need for disruptive and costly removal and replacement. The school also took the opportunity to replace 91 Georgian wire rooflights in order to meet current health and safety regulations.
