# Case Study

**Project:** Office Building , Hemel Hempstead  
**Product/System:** Tor Coatings Elastaseal 15 yr System

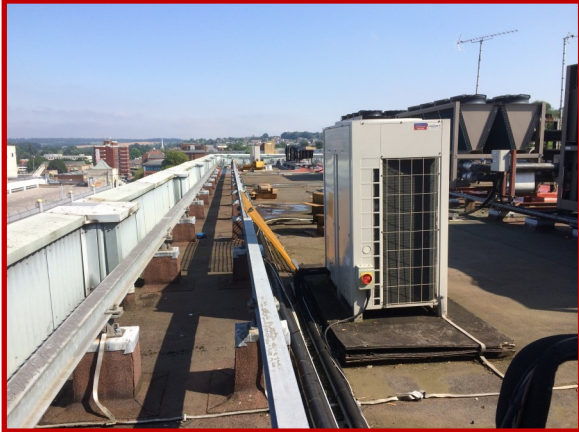
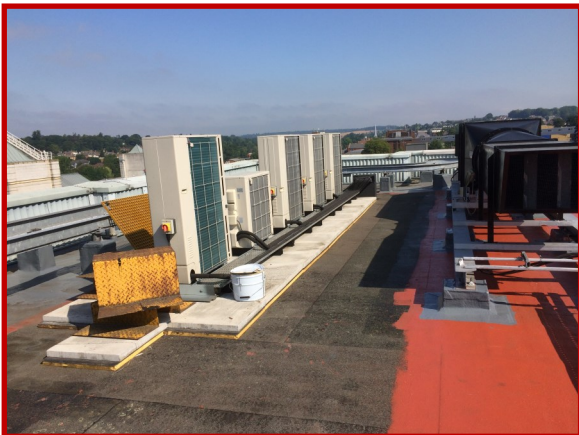
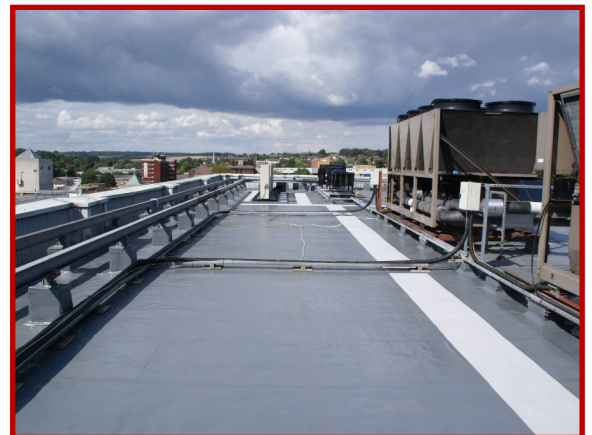
The existing felt overlay had failed in many places and subsequent repairs had exacerbated the matter, creasing and moving, leading to further water ingress into the building. In looking for a long lasting solution to this, it was also necessary to take into account the large amount of plant on the roof.

Gables UK Ltd used the Tor Elastaseal System, which was applied seamlessly, not only on the large open areas of the roof, but also around the bases of the plant, making the whole area watertight. For future plant maintenance, a contrasting non-slip walkway was added.

The finished application is seamless, waterproof and a credit to the Gables Application Team. Both the client and Tor Coatings are delighted with the results.
