Case Study

Project: Family Care Unit
Product/System: Warm Roof 120mm Insulation & Tor Coatings Elastaseal 20 Year Waterproofing System
Size/Value: 1,200m²

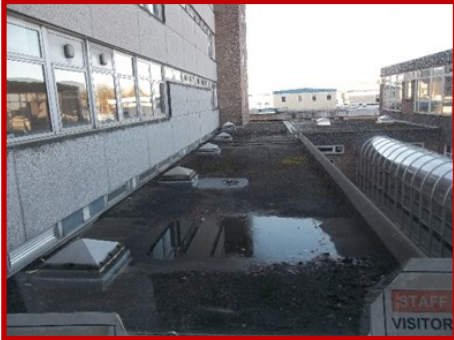
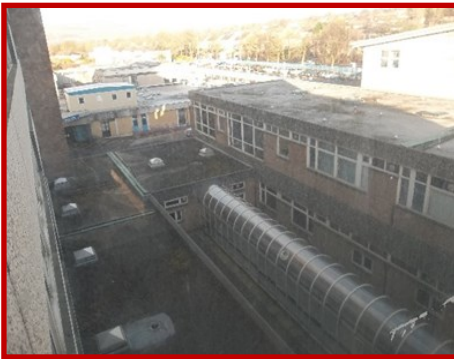
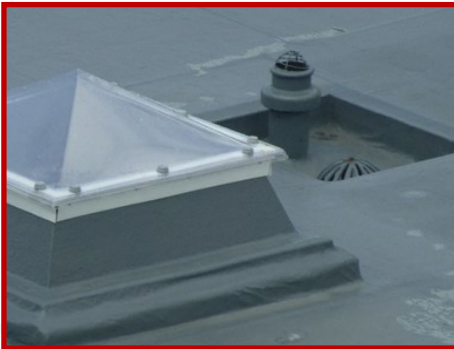
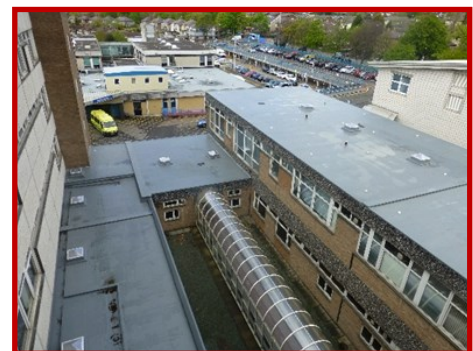
The Hospital have had major roofing problems with old building stock. The old asphalt roofs on the Family Care Unit had very little thermal value and large areas of blistered and split asphalt, allowing water in to the building, flooding patient wards and damaging expensive, sensitive equipment.

Gables carried out a survey of the roof areas, took core samples and offered a warm roof overlay solution to bring the roof up to current building regulations. The building had to remain occupied throughout the contract.

Stone chippings were removed at weekends and works were programmed around the patient care, in particular, the replacement of the roof lights with new triple skin units. Gables installed 120mm PIR insulation over the prepared roof deck and a new carrier membrane before applying the Tor Coatings Elastaseal 20 system.
