# Case Study

**Project:** Lancashire Police Constabulary Training Centre  
**Product/System:** Tor Coatings Elastaseal 15 Year System  
**Size/Value:** 1100m<sup>2</sup>

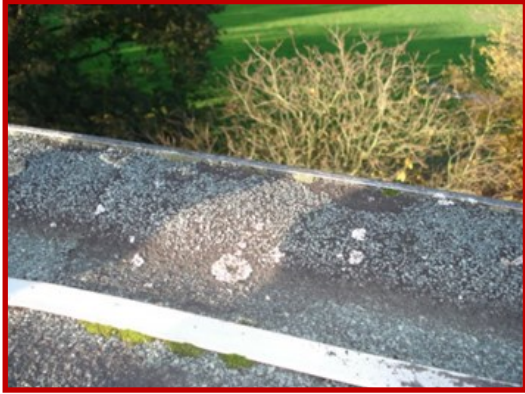
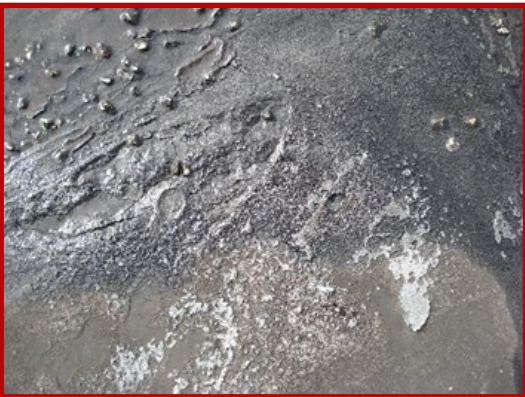
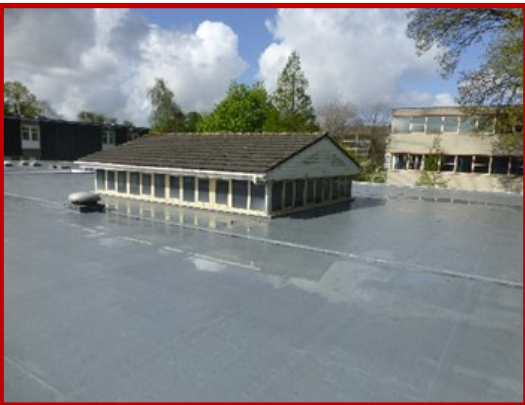
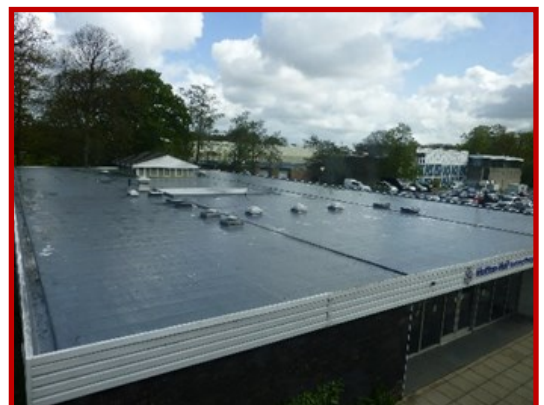
All works were completed on time and on budget and the pictures above clearly show the quality of finish and condition of site after handover

All moss algae and stone chippings were removed from the deck. Any previous failed repairs were removed and made water tight. The roof was power washed to remove all surface contaminants before applying the Tor Coatings Elastaseal system, consisting of a fully reinforced base coat and a liquid applied top coat giving a 15 year single point guaranteed system.
