Case Study

Project: St Mark's House, Birkenhead
Product/System: Sika Liquid Plastics Decothane HS & Flexcrete Technologies Ltd Monolevel 844SP
Size/Value: 1600m²

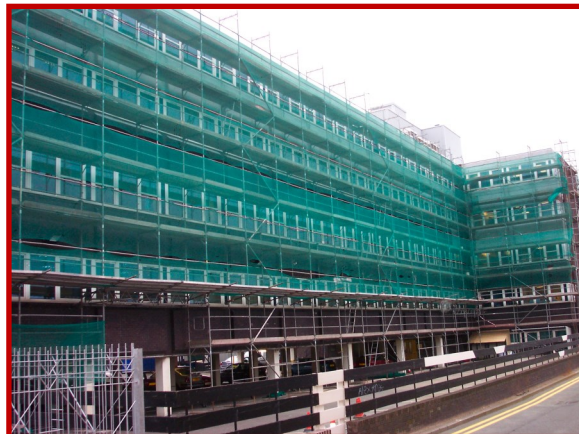
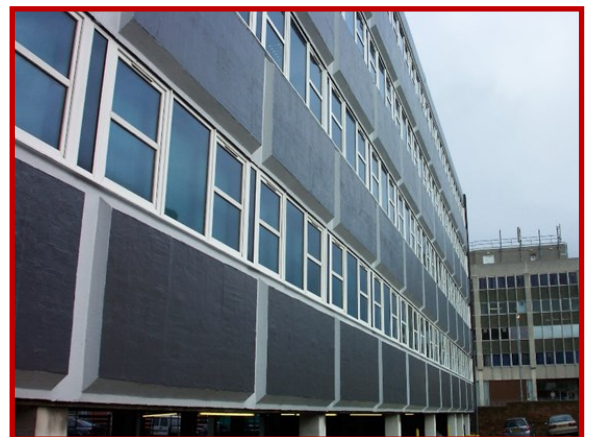
St Mark's House, an office block in Birkenhead, was suffering from water ingress through the walls. The construction below the windows on each floor consisted of brick slips mounted on a prefabricated board. The brick slips were becoming loose and falling off in places, causing the water ingress and presenting a potential danger to the office workers below.

Flexcrete Monolevel 844SP, a cementitious repair mortar, was used to flush point the brick slips and hold them in place. Decothane HS, a seamless waterproofing membrane, was then applied to fully waterproof the building and ensure that no further spalling would occur.
